Manhole Inspection Summary

Manhole # S15GG2013MH

Location Address: **1900 MAYWOOD AVE**

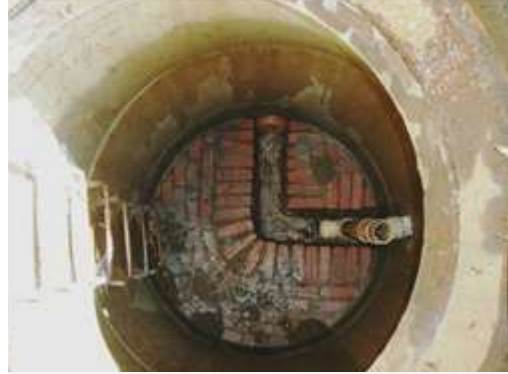
Top View

Evidence of surcharge - Bench debris.
Channel debris.

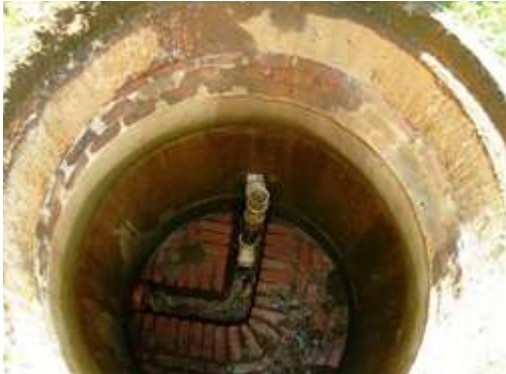
Defect

Frame Offset: **0** (in.) Condition: ☐ Sound ☐ Cracked ☒ **Leaks**

Condition: ☐ Sound ☐ Cracked ☐ Root Intrusion ☐ Loose Brick ☒ **Deteriorated**

Infiltration: ☐ None ☒ **Joint** ☐ Cracks ☒ **Mortar** ☐ Roots ☐ Wall

Frame leaks. Adjustment deterioration
and infiltration. Corbel and Barrel
infiltration - other side.

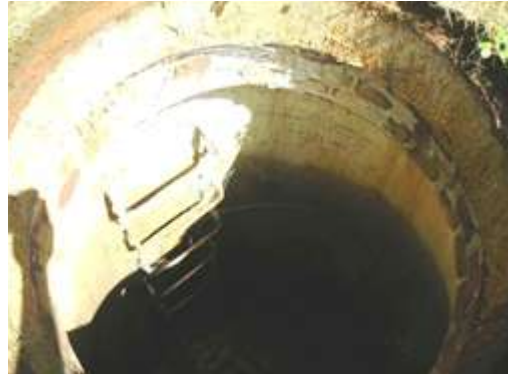
Defect

Frame leaks. Adjustment deterioration
and infiltration. Corbel infiltration.

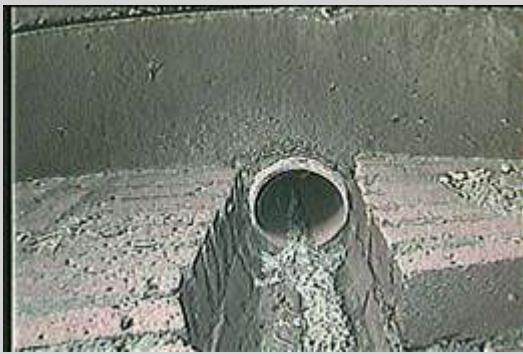
6 in. Circular Gravity Sewer Pipe Out @ 12 O'Clock

Channel deterioration and debris.

Deposits: ☐ None ☐ Mud ☐ Sludge ☒ Debris ☒ Grease

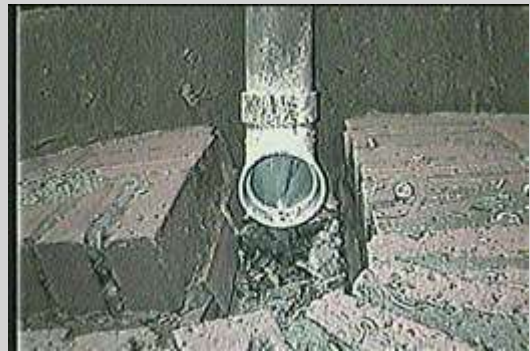
Drop In @ 3 O'Clock

Drop: **Inside**

Drop Condition: **Open**
